Thorndike Pond

2013 Dam Improvement Project

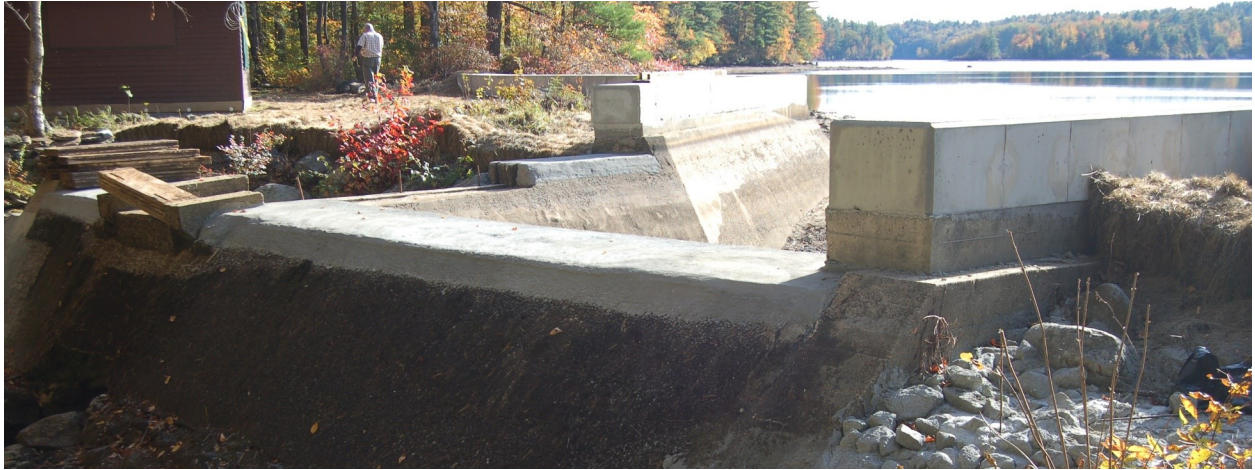
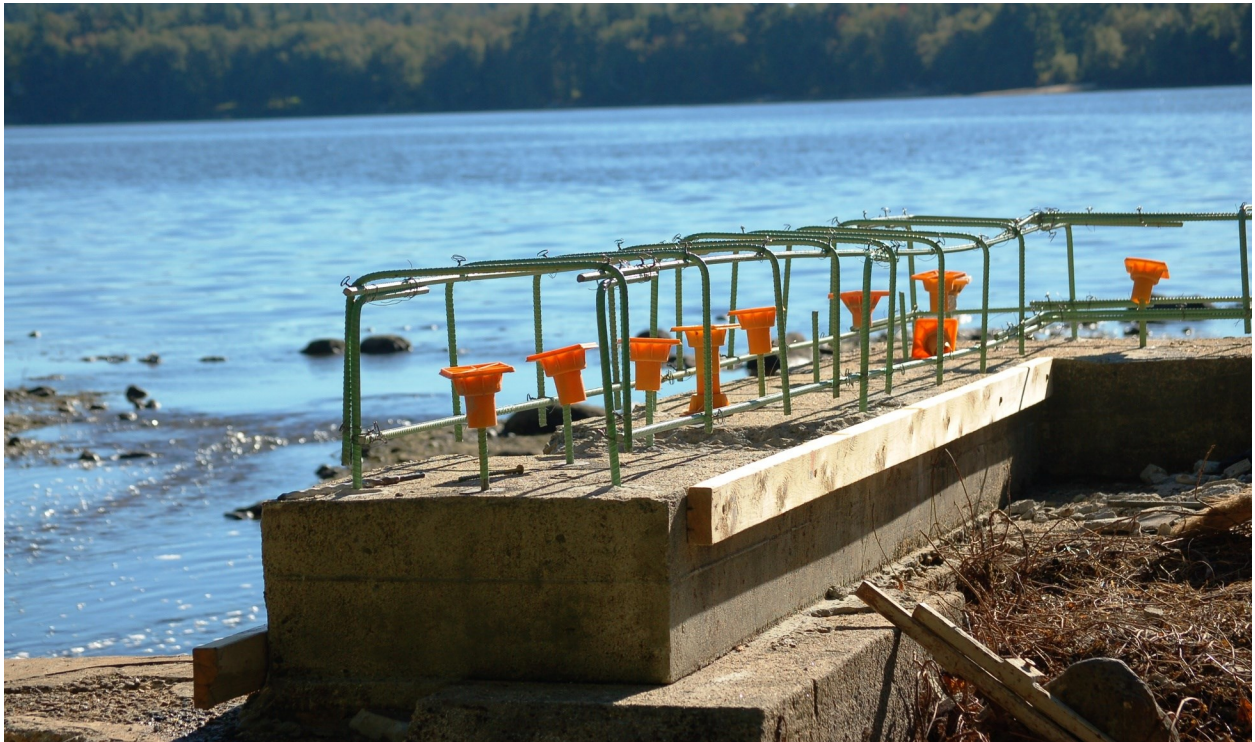
Raising Dam Abutments

We were required to raise the height of the abutments so we had 12 inches of freeboard during a 50 year (we did a 100) storm, which had been redefined upward after the start of the project.

The increased abutment heights can be seen on both sides of the dam in the above picture, they are the lighter color. They were raised about 14 inches. The rebar can be seen in the picture below. The vertical pins with the orange caps (put on only for safety, and later removed) are drilled into the existing abutments and take the sheer force, the U-shaped pieces are to hold the poured cement together under stress.

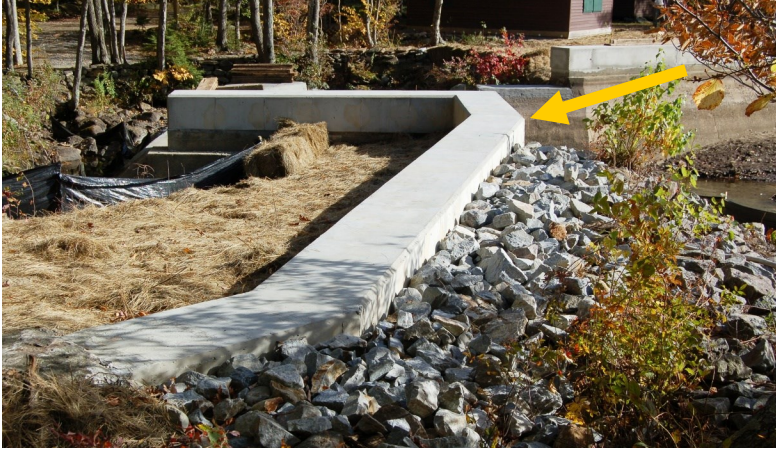
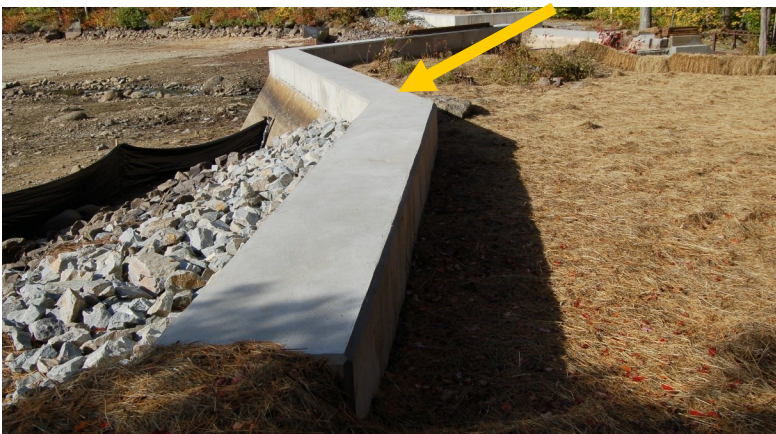
Extending Abutments

After raising the abutments we had to extend them so water would just go around the sides.

The abutments were extended on both sides from where the yellow arrows indicate. The top picture is of the north side of the dam, the lower picture is of the south side. For these extensions, the lake was lowered, a base was dug about 5 feet below grade, and the whole dug area was filled with concrete with the rebar in place, all the way to the bottom.

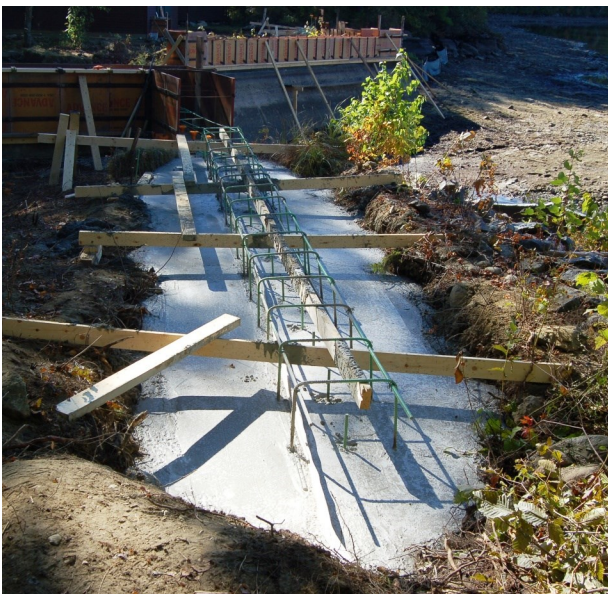
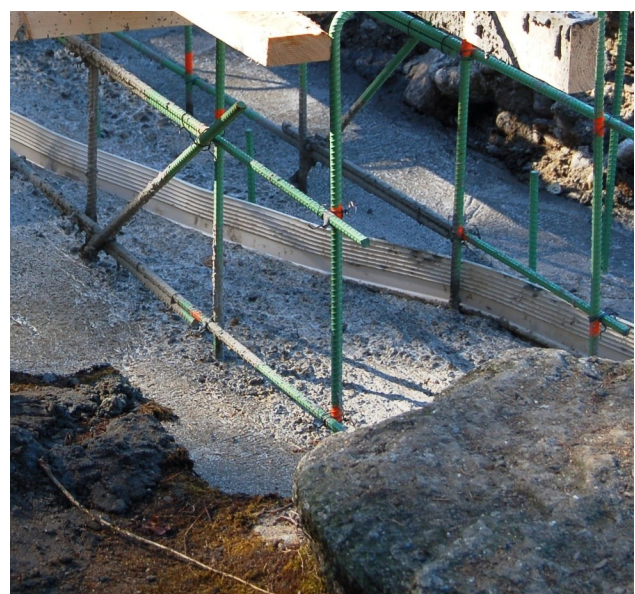
In addition to the rebar, a plastic strip (see bottom left picture) was installed to stop water from seeping through the joint. A different but equally effective strip was used for the joint with the existing abutments.

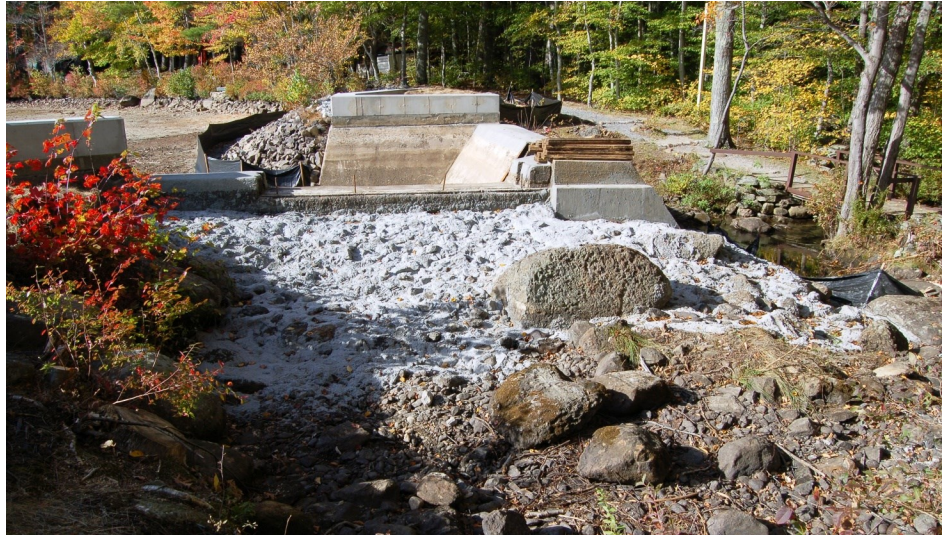
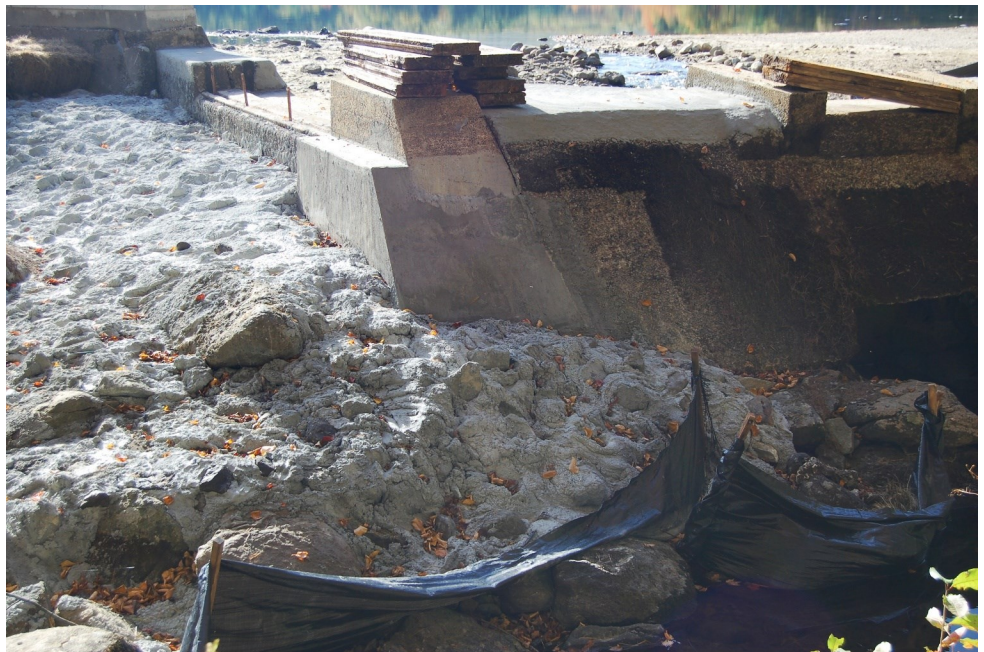
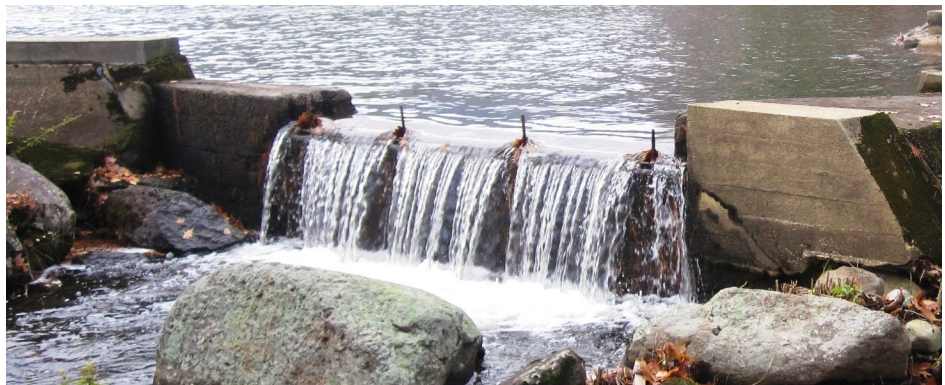
Stabilizing Spillway

There was concern that water going over the broader spillway was dropping some distance and could undermine the dam in that area, the solution was rip-rap to within 1-foot of the spillway to reduce the drop and to create a flow rather than a falls. Grout was added to enhance stability. The result is shown in the top two pictures from two different angles, the previous condition is shown in the bottom picture (with the board out, with the board in the drop is further).

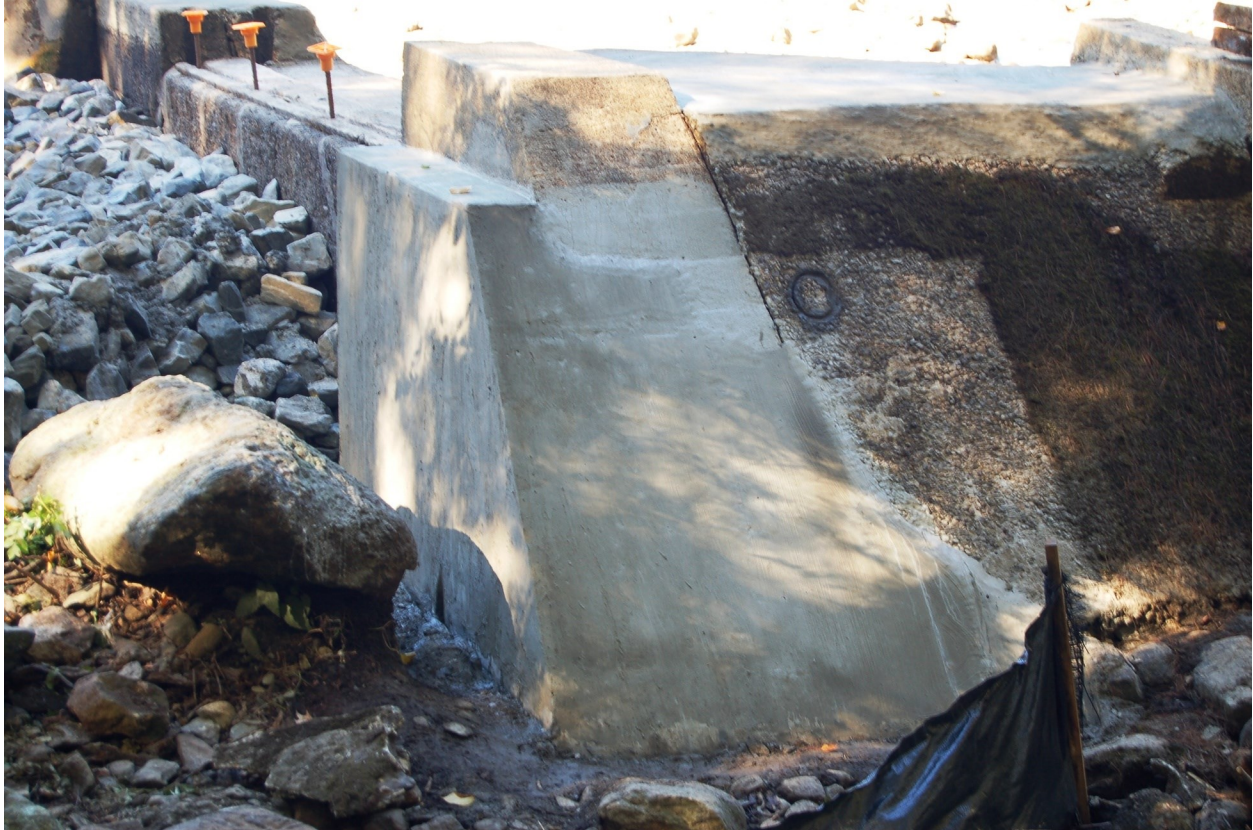
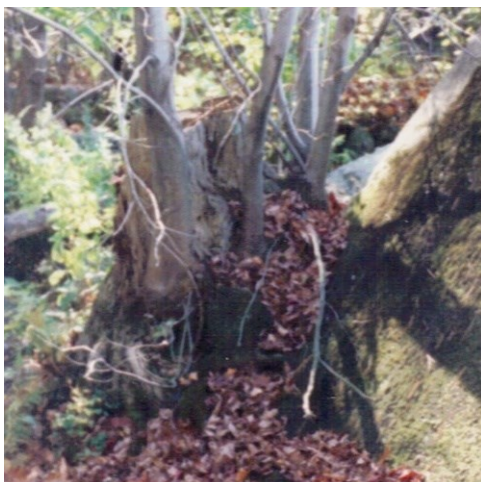
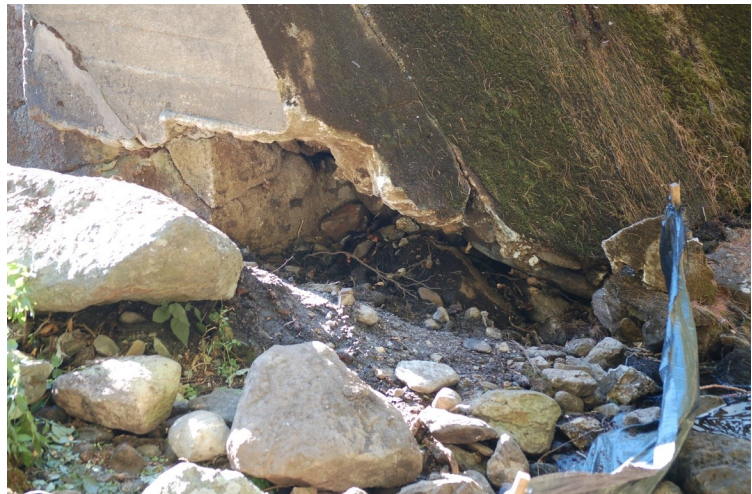
Eliminating stump from structure

There was a stump in one corner of the dam that had been just poured around but has since deteriorated.

The picture below was from 1990 showing thea stump that the dam was poured around. 25 years later the stump is still there but deteriorating with additional organic growth (shown in the picture bottom right after it was cleaned out). This was repaired by removing the stump, installing pins to hold the whole structure together and pouring concrete into the void

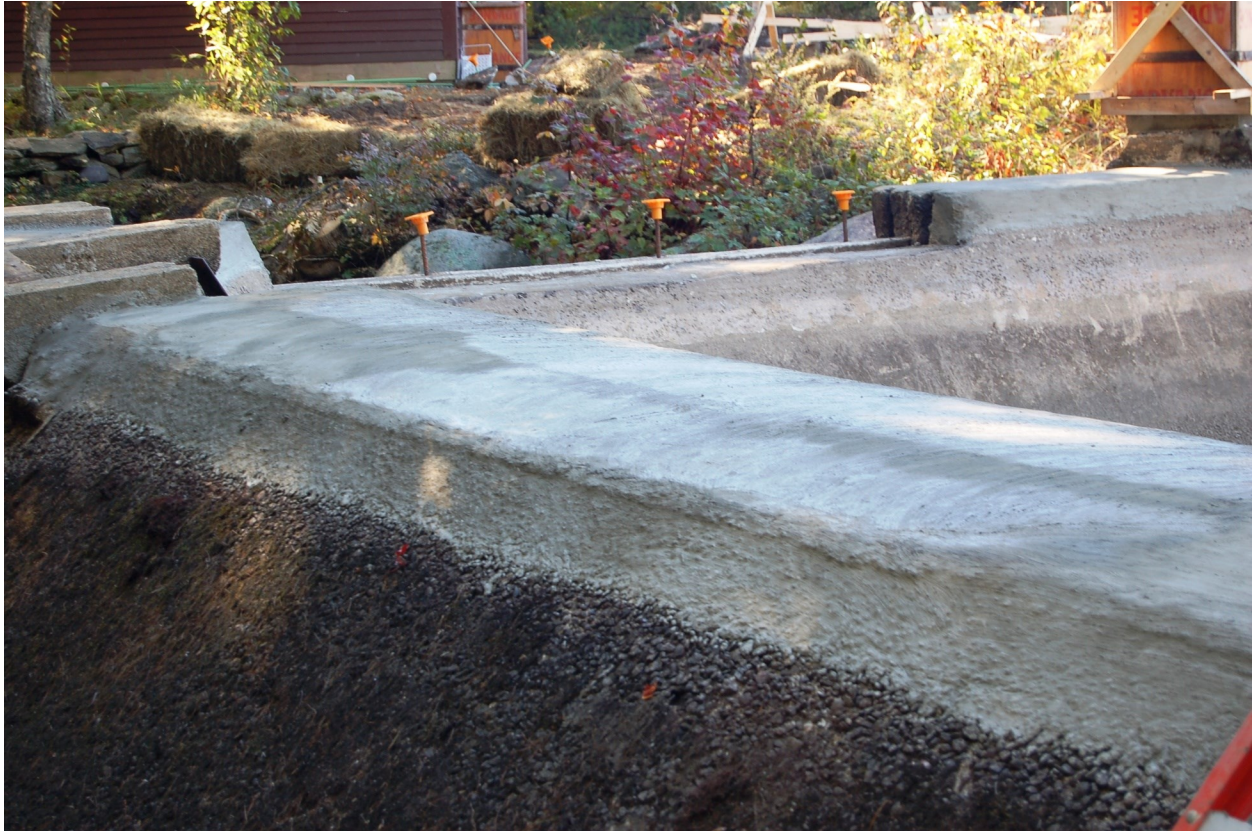
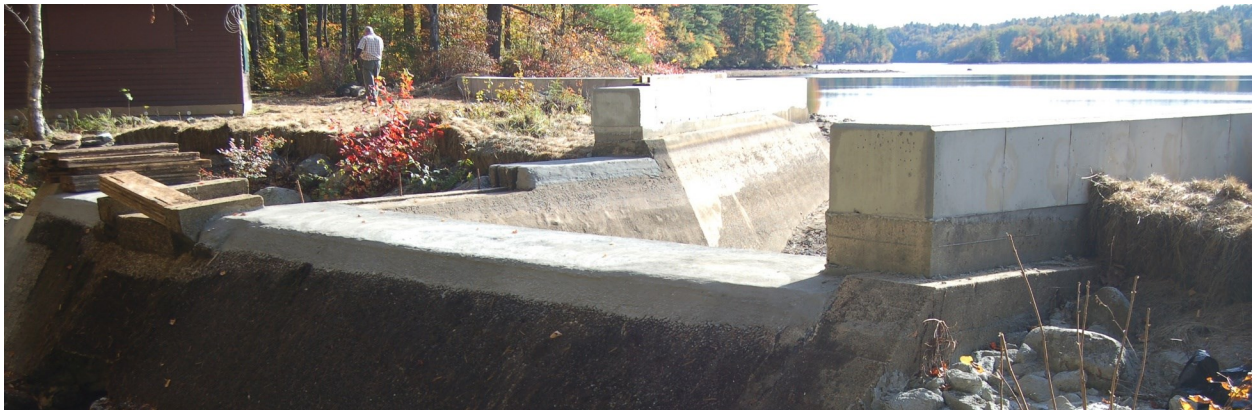
Repair Spillway Flaking

Cement on the top of the dam was pitted and flaking. This was repaired with a strong grout material as shown in these two pictures.

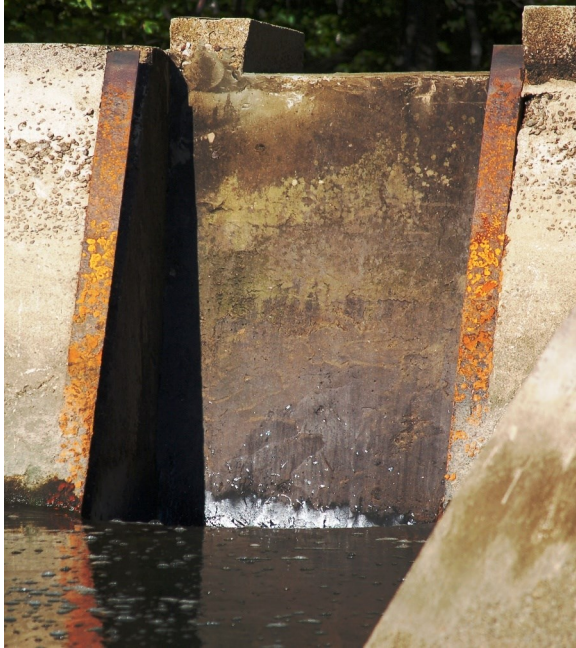
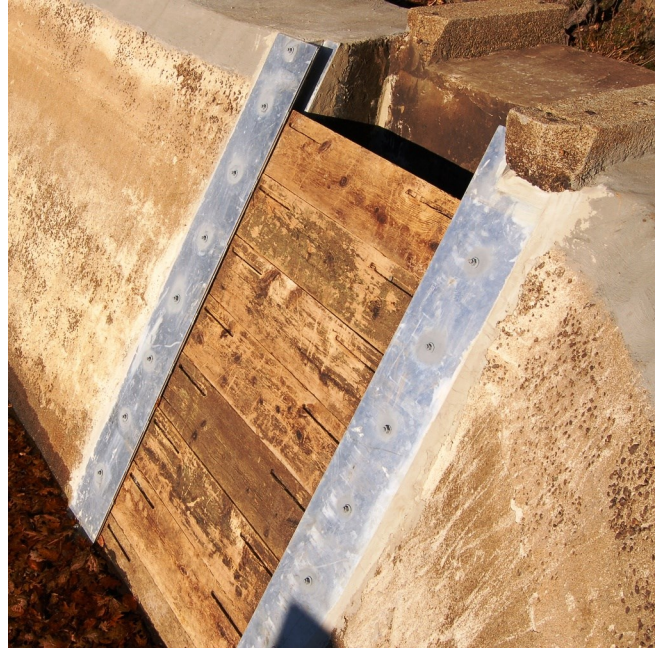
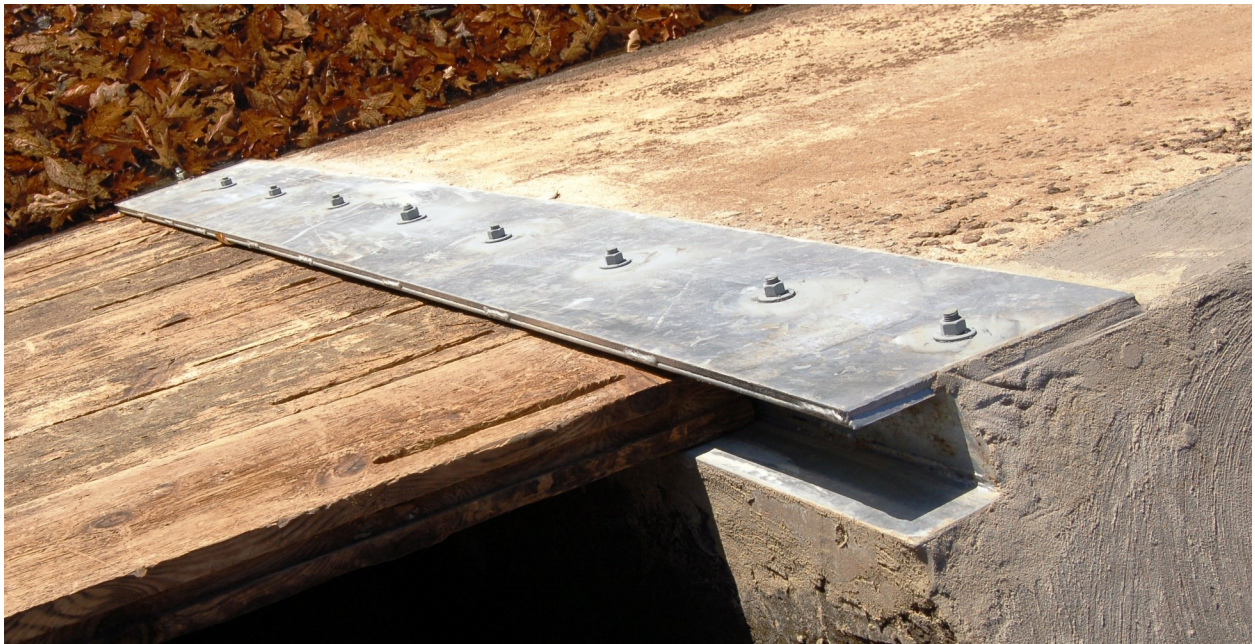
Replaced Brackets on Spillway

The brackets holding the spillway boards were rusted and the engineer suggested they be replaced after the project was otherwise completed. The before and after pictures are shown above. A closer view looking down the brackets showing the thickness is below.
